On May 3, 2019, at 2142 eastern daylight time, Miami Air flight 293, a Boeing 737-81Q, registration N732MA, departed the end of runway 10 at Jacksonville Naval Air Station (KNIP), Jacksonville, Florida, and came to rest in shallow water in St. Johns River. There were no serious injuries to the 142 passengers and crew onboard. The airplane was substantially damaged. The airplane was operated by Miami Air International as a Title 14 *Code of Federal Regulations* Part 121 supplemental non-scheduled passenger flight from Leeward Point Field (MUGM), Guantanamo Bay, Cuba, to KNIP.

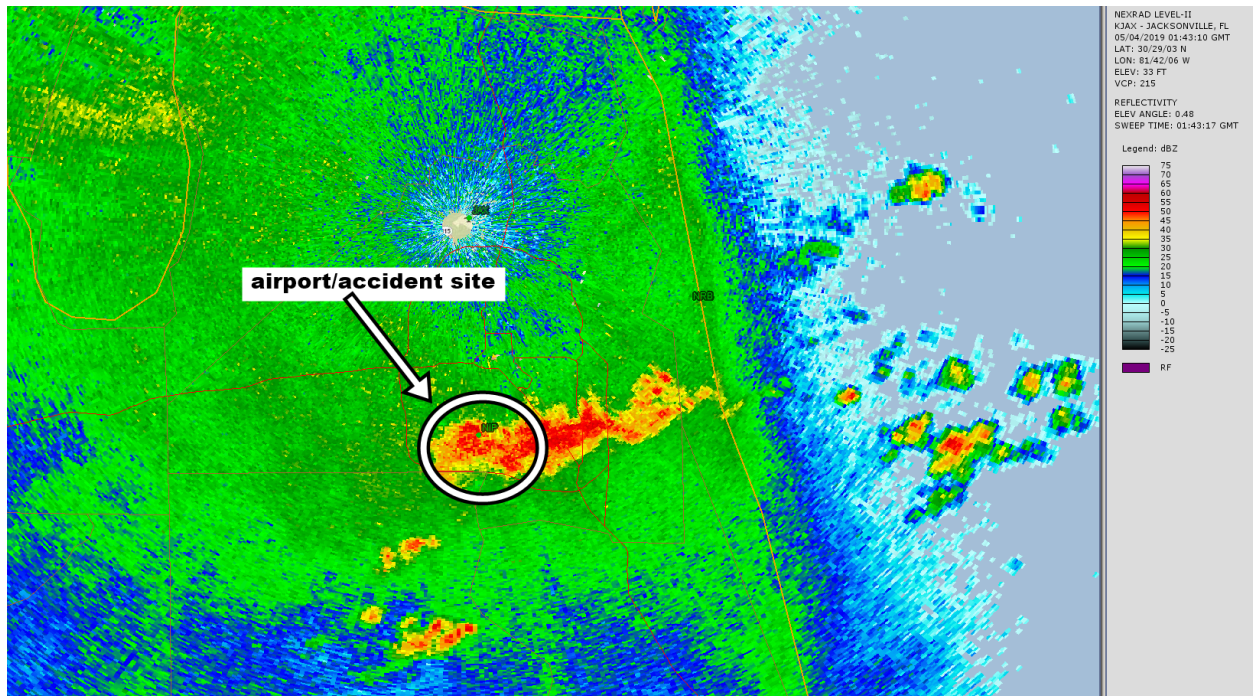
The KNIP ASOS special weather observation at 2145 (3 minutes after the accident) indicated wind from 290° at 8 knots with gusts to 16 knots, 3 miles visibility, heavy rain and thunderstorms, mist, scattered clouds at 800 ft agl, broken ceiling of cumulonimbus clouds at 1,500 ft agl, overcast skies at 3,200 ft agl, temperature 24°C, and dew point 22°C. The remarks included that 0.63 inch of precipitation had fallen since 2053. Figure 1 shows the Jacksonville (KJAX) WSR-88D base reflectivity image for the 0.5° elevation scan initiated at 2143:17.

Figure 1. National weather Service NEXRAD weather radar at 2143. Airport is near the center of the circle.

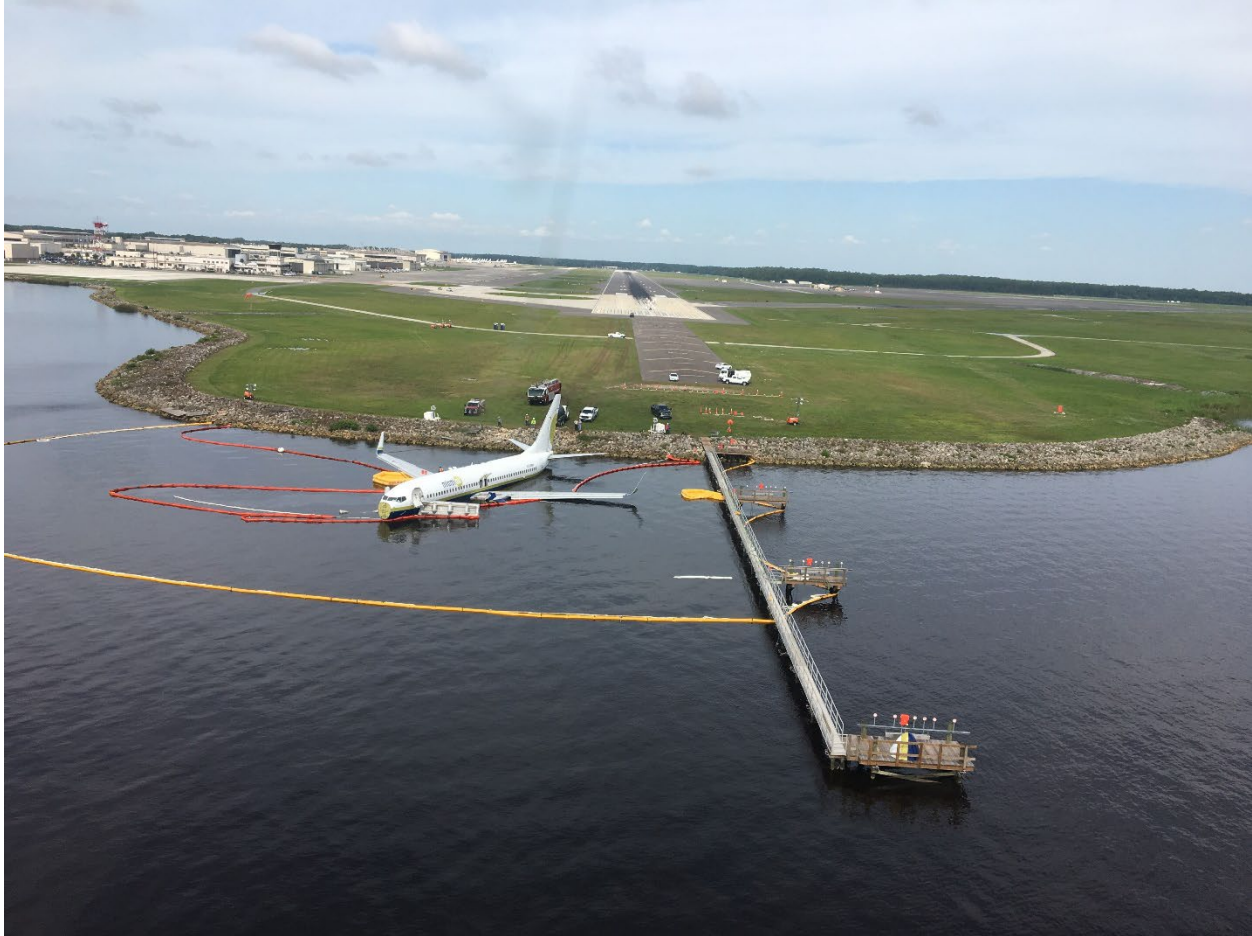
The airplane impacted a rock embankment at the end of the runway 10 overrun area before coming to rest in the St. Johns River about 1,200 ft from the end of runway 10 (see figure 2). The center of the airplane was about 100 ft east of the river's shoreline and about 75 ft south of the runway 28 landing light pier. The water where the airplane came to rest was 3-5 ft deep, depending on the tidal conditions. The embankment had a distinct area of disturbed rocks, consistent with the engines and main landing gear impacting the embankment. The airplane was mostly intact, but both main landing gear had separated from the airplane and were also located in the river.

Figure 2. View looking west at the airplane and runway.

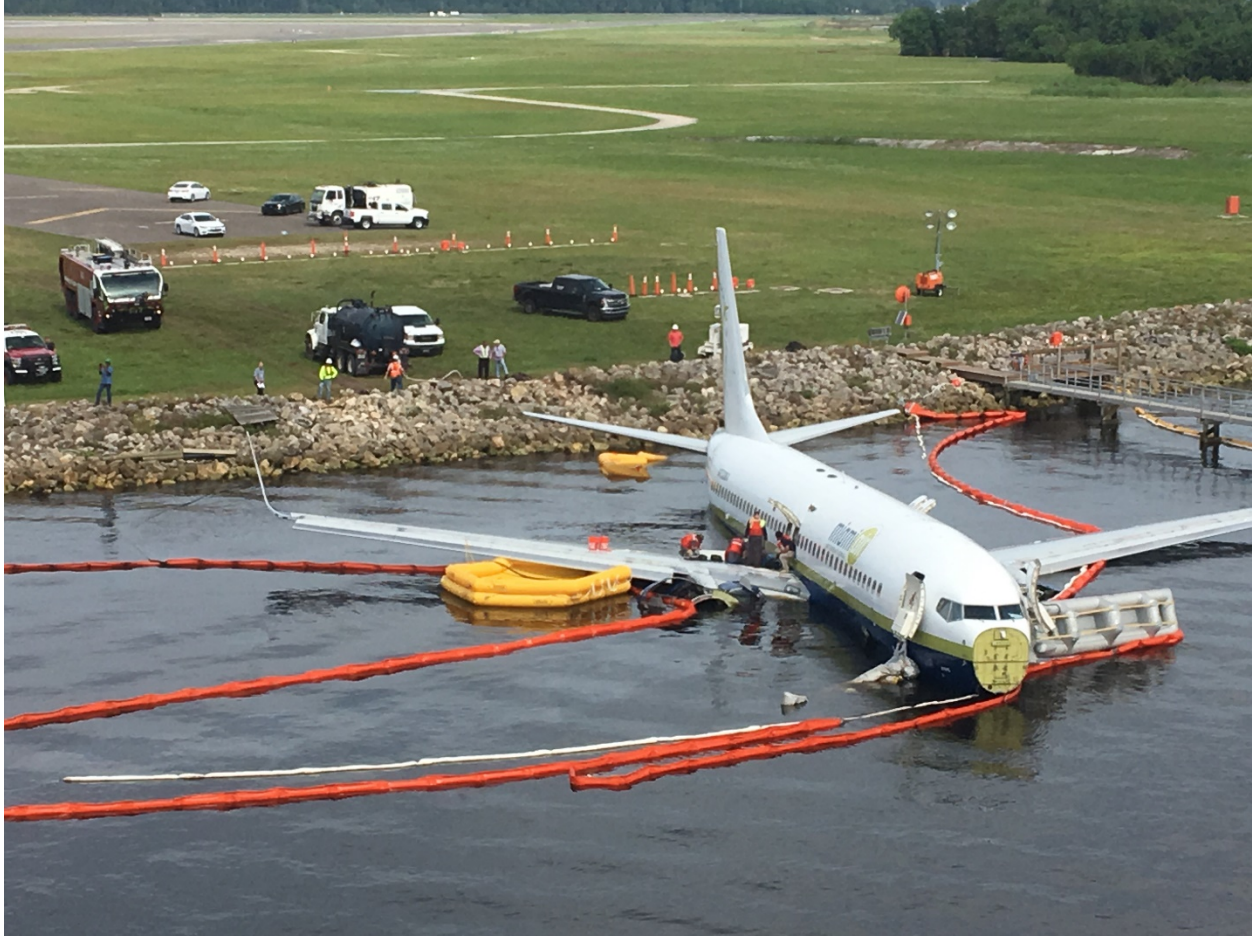
The two forward exits and the four overwing exits were used to evacuate passengers and crew from the airplane (see figure 3). The escape slide at the right forward door had deflated by the time the NTSB arrived on scene, and the escape slide at the left forward door was found fully inflated and attached to the airplane. Four rafts were deployed during the evacuation, and two sustained damage. Interviews with the flight and cabin crew have been conducted regarding the landing and evacuation.

Figure 3. Closeup view of the airplane showing several rafts and door slides.
